Docket No. 217 – Development and Management Plan Inspection

Northeast Utilities Service Company Certificate of Environmental Compatibility and Public Need for the construction of a 345-kV electric transmission line and reconstruction of an existing 115-kV electric transmission line between Connecticut Light and Power Company's Plumtree Substation in Bethel, through the towns of Redding, Weston, and Wilton, and to the Norwalk Substation in Norwalk, Connecticut.

Date: May 25, 2006

Location: Transition Stations: Hoyts Hill, Archers Lane, Norwalk Junction

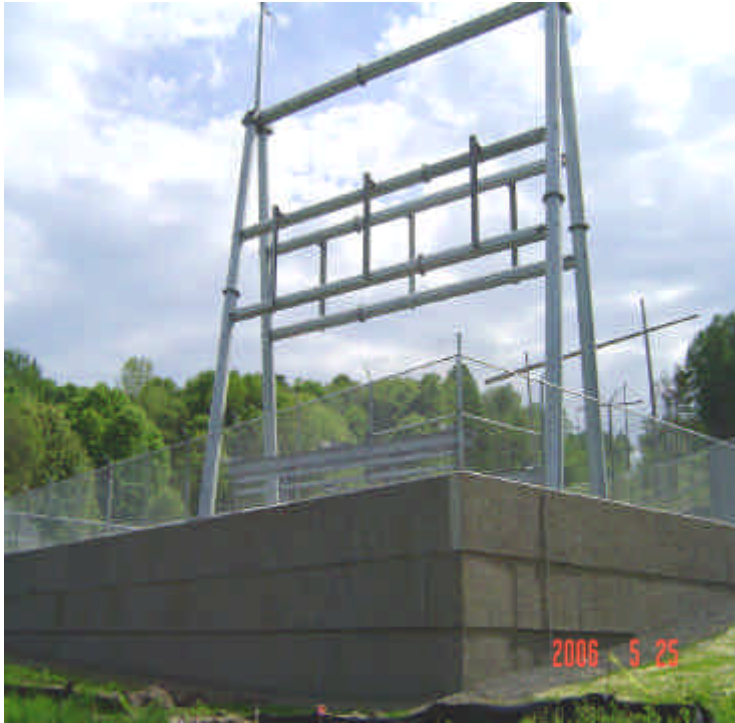
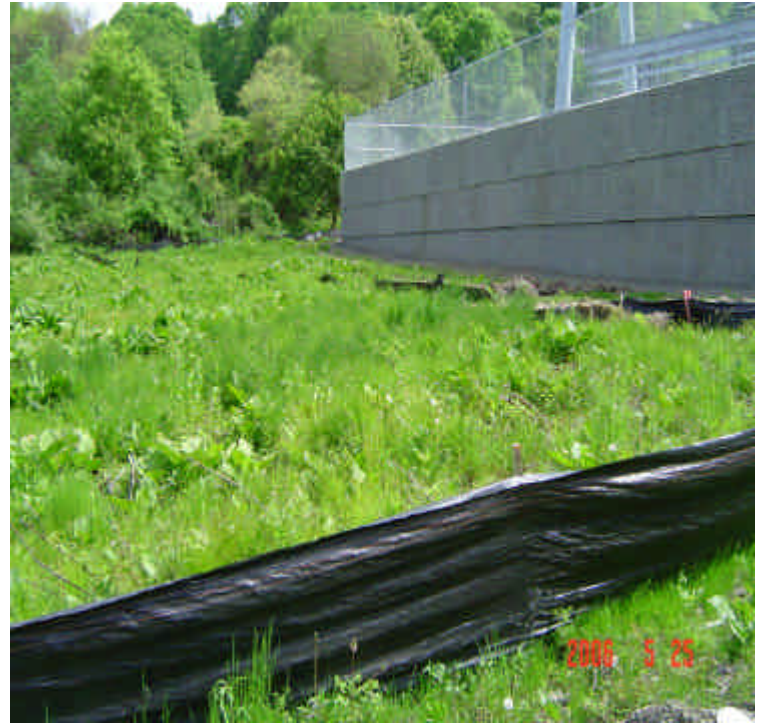
Hoyts Hill Transition Station: Photo on the left shows a view of the station pad with the structure in place. Photo on the right shows the wetland with good controls in place and vegetation growing well. 5/25/06

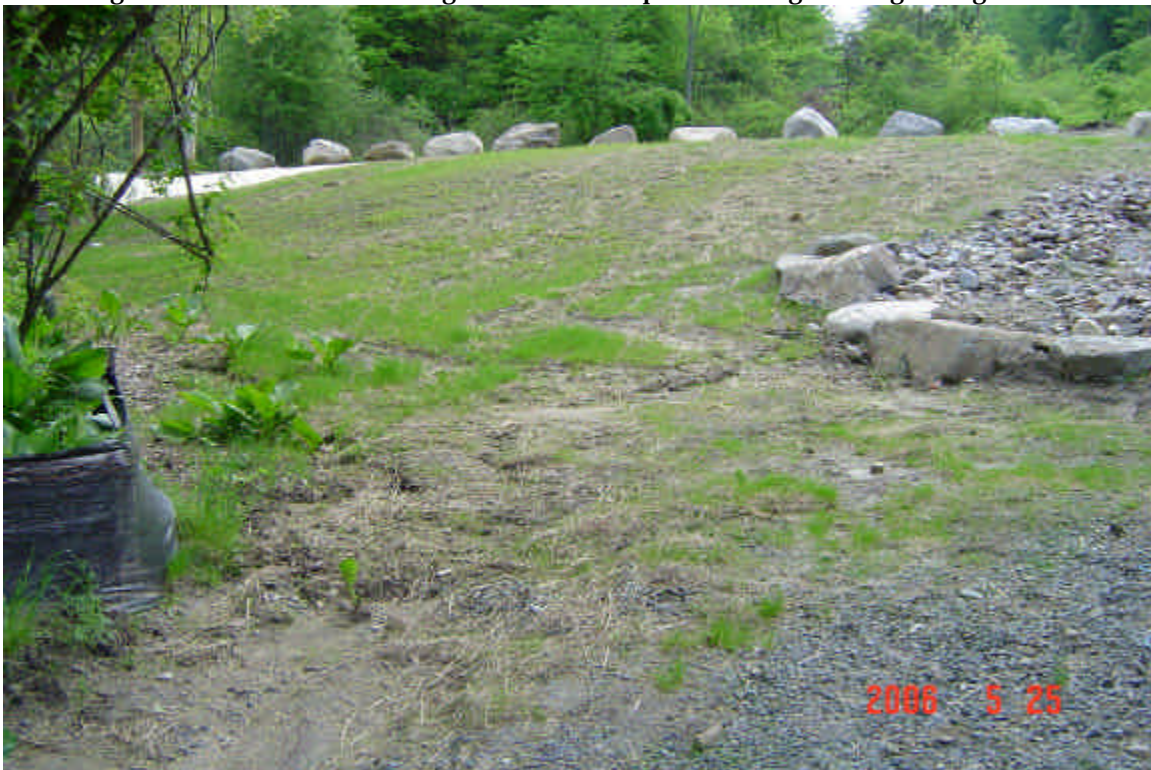
Erosion and Sediment Controls	<p>-Hoyts Hill: The perimeter silt fence along the wetlands at the rear of the station remains in good shape. 4/6-5/25/06.</p> <p>-The northern slope was in good shape and the southern slope had been restored but there are indications the gully was returning. 5/17-5/25/06.</p> <p>- Archers Lane: Sediment removal efforts are still needed at the 1st</p>	<p>-Monitor and maintain the fence as necessary. 4/6-5/25/06 Vegetation is growing very well in the adjacent wetland 5/25/06</p> <p>-Continue to monitor for stabilization along this slope. If grass cannot stabilize quickly, the outlet pad may still need to be extended. 5/25/06.</p> <p>-Any easily accessible deposits of sediment need to be removed. (Some are</p>	<p>- N/A</p> <p>- Needs monitoring</p> <p>- Still needs attention</p>

View of the southern slope where the larger gully and smaller rills have recently been restored. However, some erosion is beginning to appear again below the outlet. Continue to monitor and extend the outlet if necessary. 5/25/06.

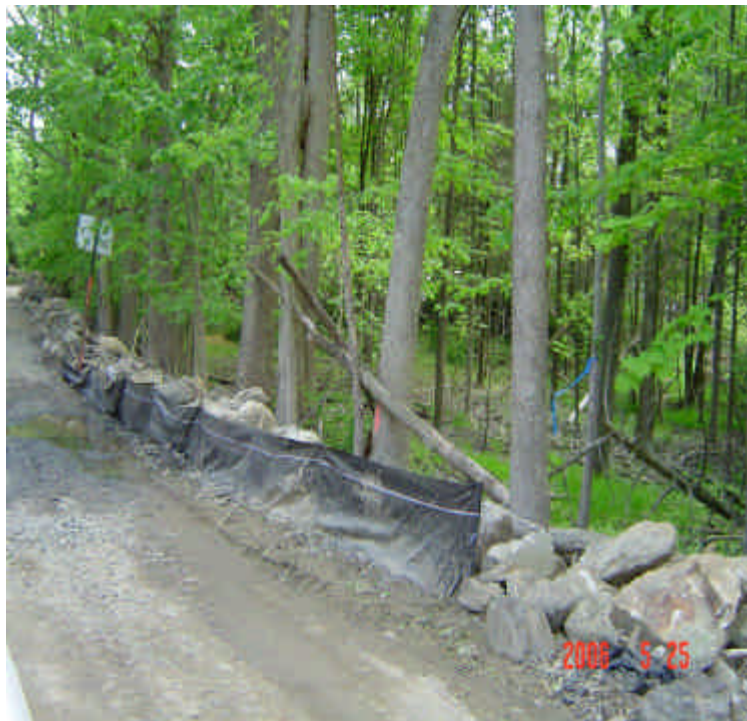
- Silt fence was installed near the stone wall along the access drive where some run-off had been seeping through. 5/25/06	- None at this time. 5/25/06	- Silt fence was installed in this location.

Archers Lane: Photo on the left shows where silt fence was re-installed along the stone wall where some run-off had been occurring from the access road. Photo on the right shows the placement of the cable spools for the 345 kV work. 5/25/06.

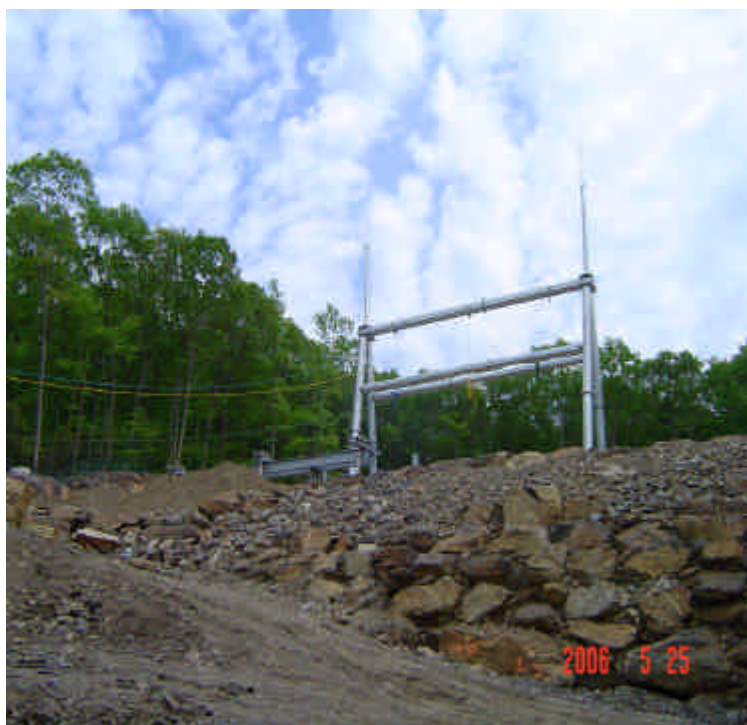
Photo on the left shows a view of the station pad with some structures in place. Photo on the right shows the sedimentation within the 1st wetland continuing to build up beyond the controls. 5/25/06.

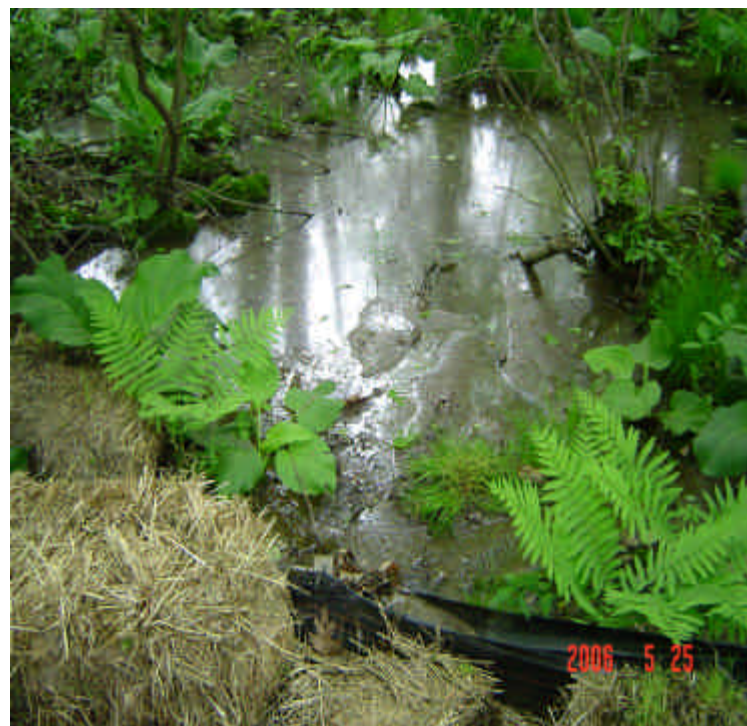
- Archers Lane: Water levels at the wetland crossings on the access road to the ROW remain below problem levels. 5/25/06.	-Crossings and controls are in good shape with the exception of attention needed near the 1 st wetland. See other sections 5/25/06.	-Needs attention
	-Slopes remain disturbed along the access road where 345kV trenching occurred. 4/26-5/25/06	-The area should be restored after vault access and work here is complete. 5/4-5/25/06	- Needs attention when work is complete

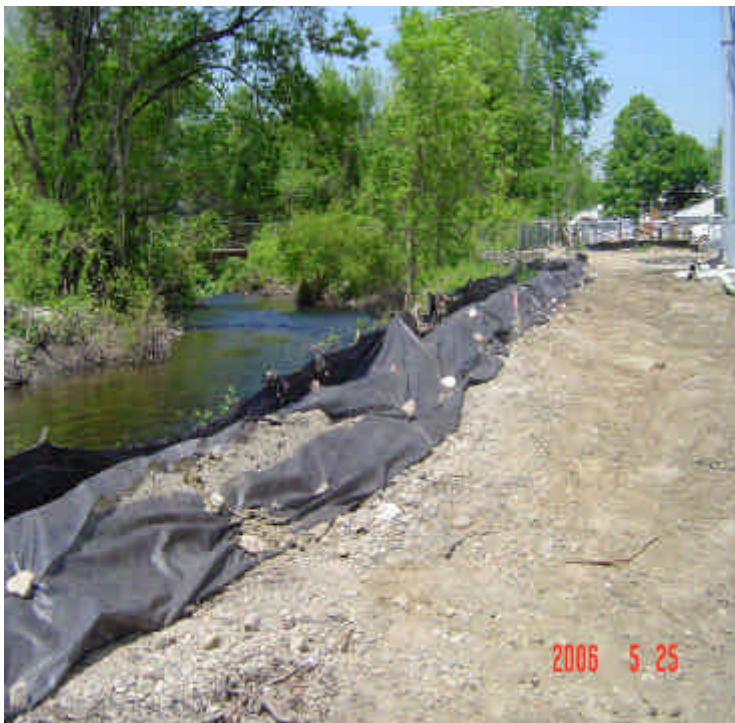
Photo on the left shows an earthen berm covered with fabric along the river. This was installed by the storage center owner and is not project jurisdictional or covered by the project permits. Photo on the right shows the wetland at the headwall with the deposits of silt from the swale. Vegetation is growing here but sediment at the outlet should be picked up by hand and removed as best feasible. 5/25/06.

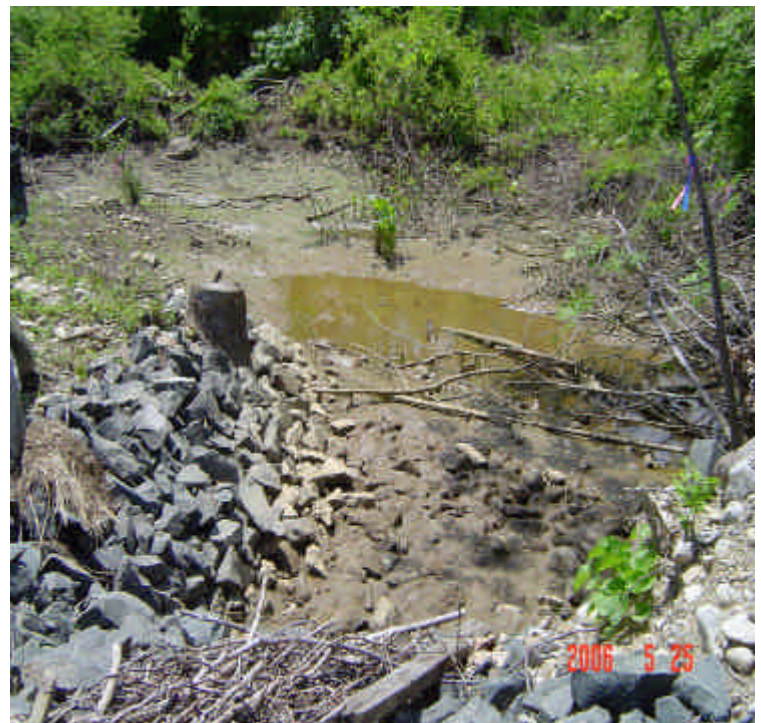
Areas of Inspection	Observation	Recommended Action	Corrected Actions
	swale is at the headwall of the wetland area. Water dried up leaving some silt behind. Wetland vegetation was growing 5/25/06	disturbed surfaces and dewatering on site. The area does not seem affected but consider removing deeper sediment buildup at the outlet. 5/25/06.	
State species of concern, threatened and endangered species	- No species of concern are located in these areas of construction.	- N/A	-N/A
Vegetative clearing limits (including trees to save or danger trees noted)	<p>-Hoyts Hill: The southern slope gully was repaired and restored but some erosion was returning. 5/17-5/25/06.</p> <p>- Archers Lane: no additional clearing was noted here. 5/25/06.</p> <p>- Norwalk Junction: - Vegetative growth continued in the area between the silt fence and the river. 5/25/06.</p>	<p>- Continue to monitor both slopes for final stabilization. 5/17-5/25/06.</p> <p>-None at this time. 5/25/06.</p> <p>- Continue to monitor and restore perimeter surfaces. 5/25/06.</p>	<p>-N/A at this time</p> <p>-N/A.</p> <p>-N/A</p>
